Schomberg Plaza Fire New York City (Harlem)

Schomberg Plaza Fire New York City (Harlem) (March 22, 1987)

This is Report 004 of the Major Fires Investigation Project conducted by TriData Corporation under contract EMW-86-C-2277 to the United States Fire Administration, Federal Emergency Management Agency.

BOARD OF INQUIRY
INTO THE MARCH 22, 1987
SCHOMBURGE PLAZA FIRE
PRELIMINARY REPORT

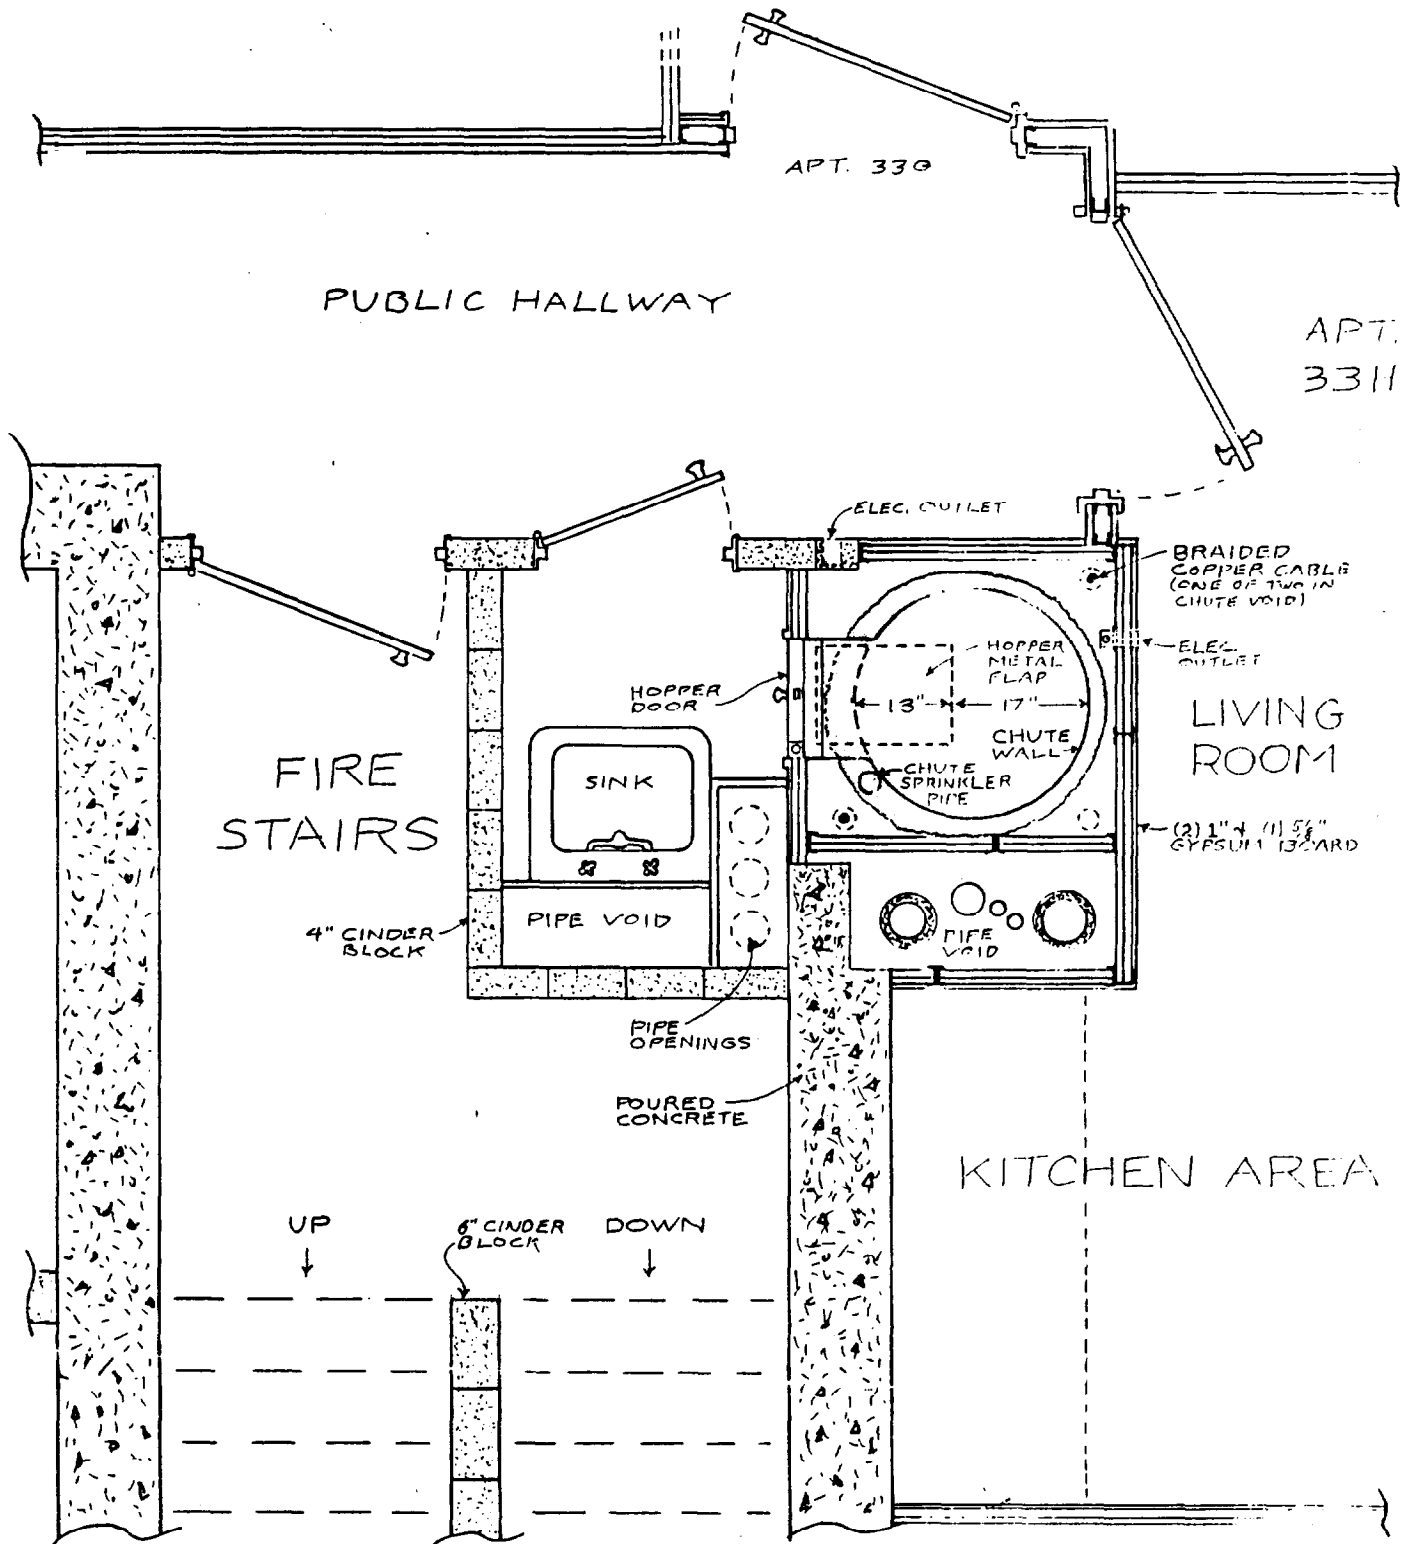
1295 5TH AVE MAN. 33RD FLOOR COMPACTOR CHUTE AREA*

However, examination of the shaft discloses that it was not built according to plan. The wall assembly was two and five-eighths inches (2 5/8") thick, not the three inches (3") called for in the "as built" plans. The Board has been unable to find any test which indicates that a two and five-eighths inch (2 5/8") assembly has a two hour fire-resistance rating. The Board is continuing its analysis of code requirements and approved assemblies as they relate to shaft enclosures and compactors and will make further comments in its final report.

horizontally into the adjoining pipe chase void via a one and one-eighths inch (1 1/8") opening at the bottom of the partition wall between the shaft enclosure and the pipe chase void. This opening was created as a result of the two inch (2") sheetrock wall resting on top of various pipe brackets and chute anchors rather than being secured to the concrete floor. (See attached diagram). In addition, it was found that the chute penetrated each floor through a concrete opening of a slightly larger diameter thereby creating a space between the outside of the chute and the concrete opening which varied from floor to floor. These openings allowed for vertical heat transfer from floor to floor within the shaft.

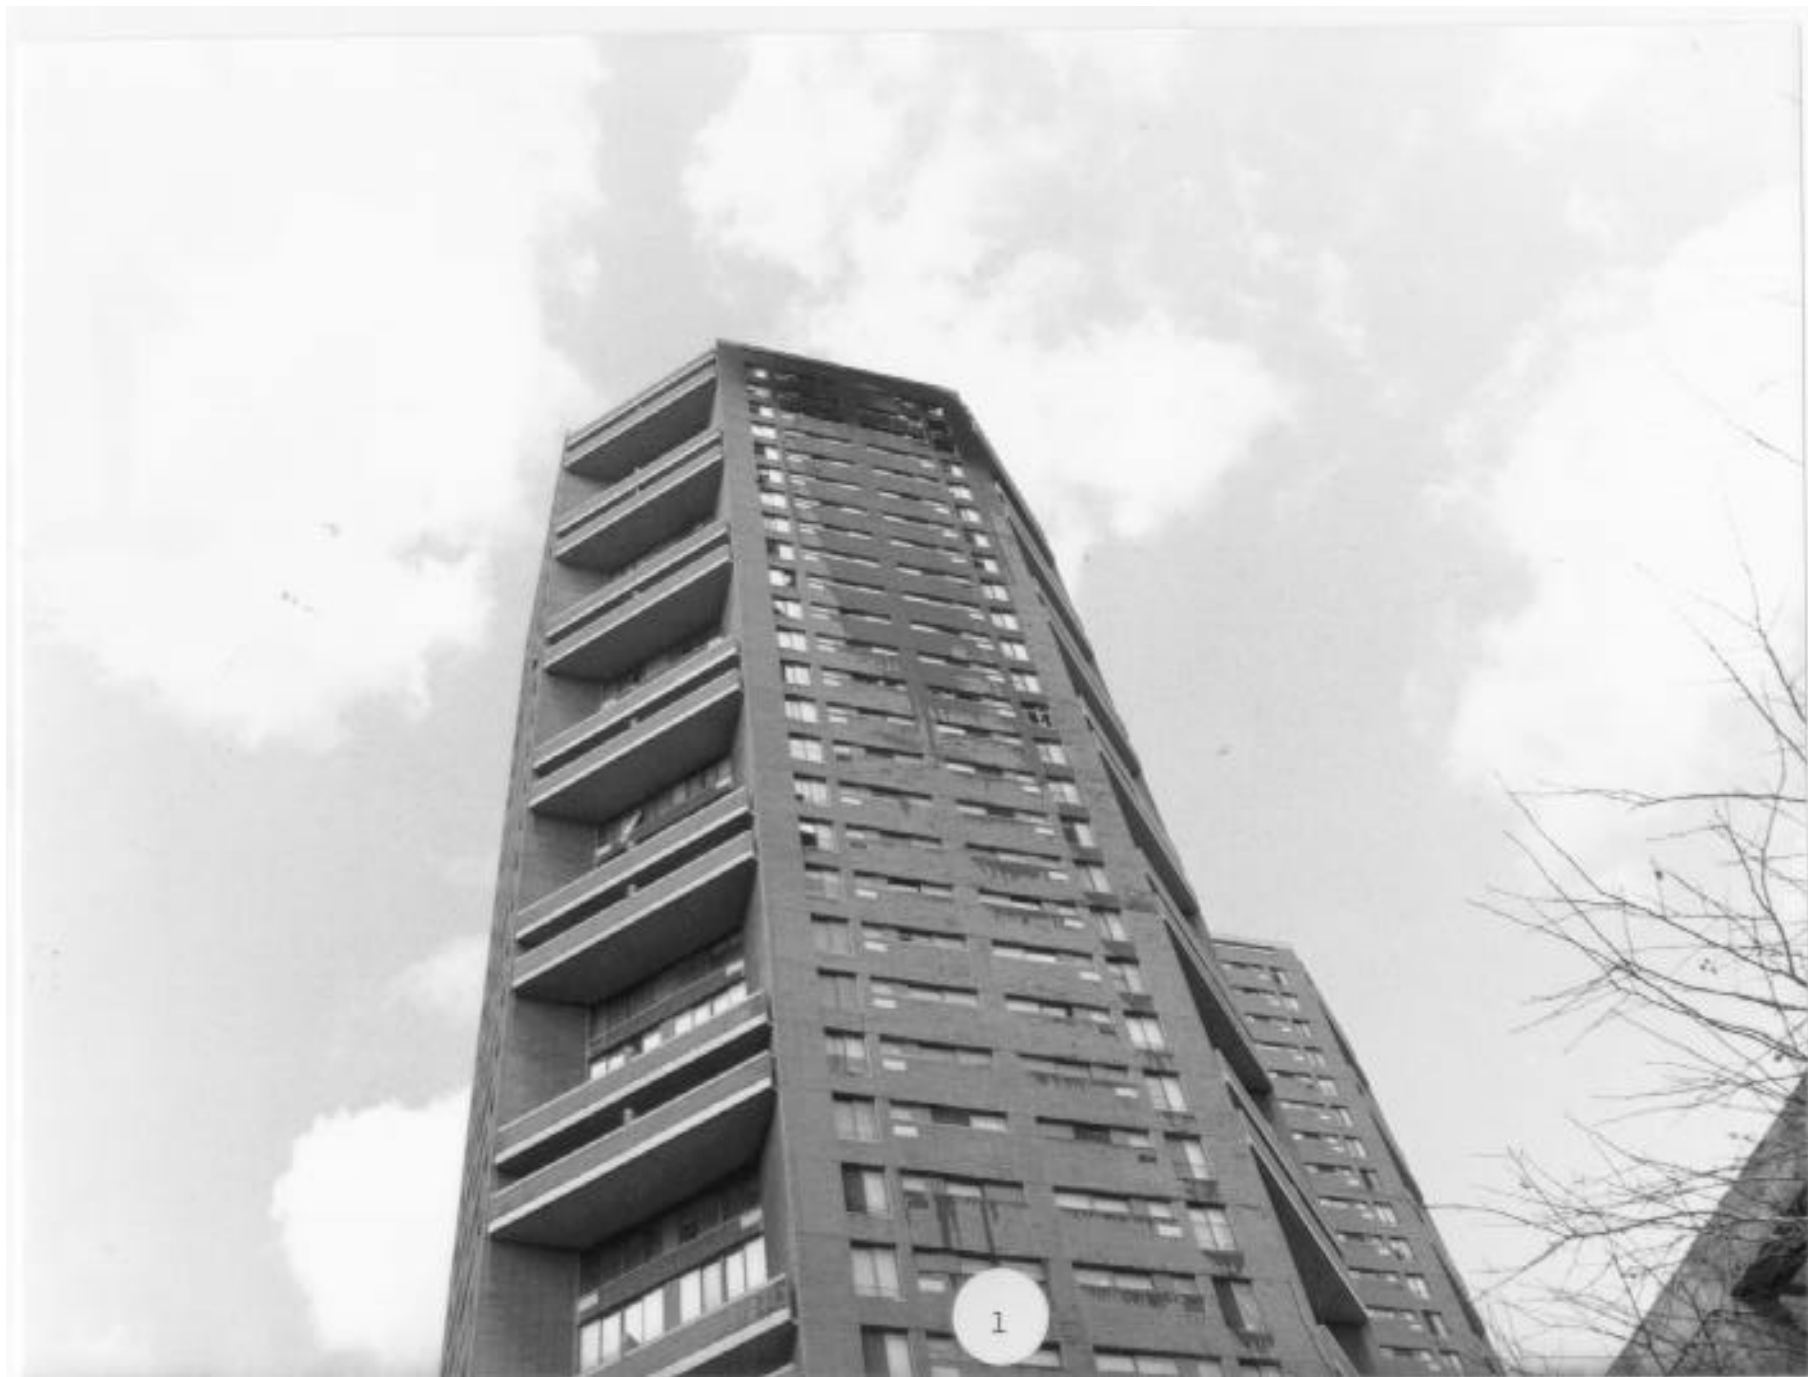
1. Exterior of fire building with water and burn patterns.
2. Compactor unit in the fire building (morning of fire).
3. Kitchen area, Apt. 23, adjoining compactor and pipe chase.
